Troubleshooting for other components

IV Cause and Action for alarm/trip relating to Software & operating procedure

b. GPS COMMUNICATION FAIL

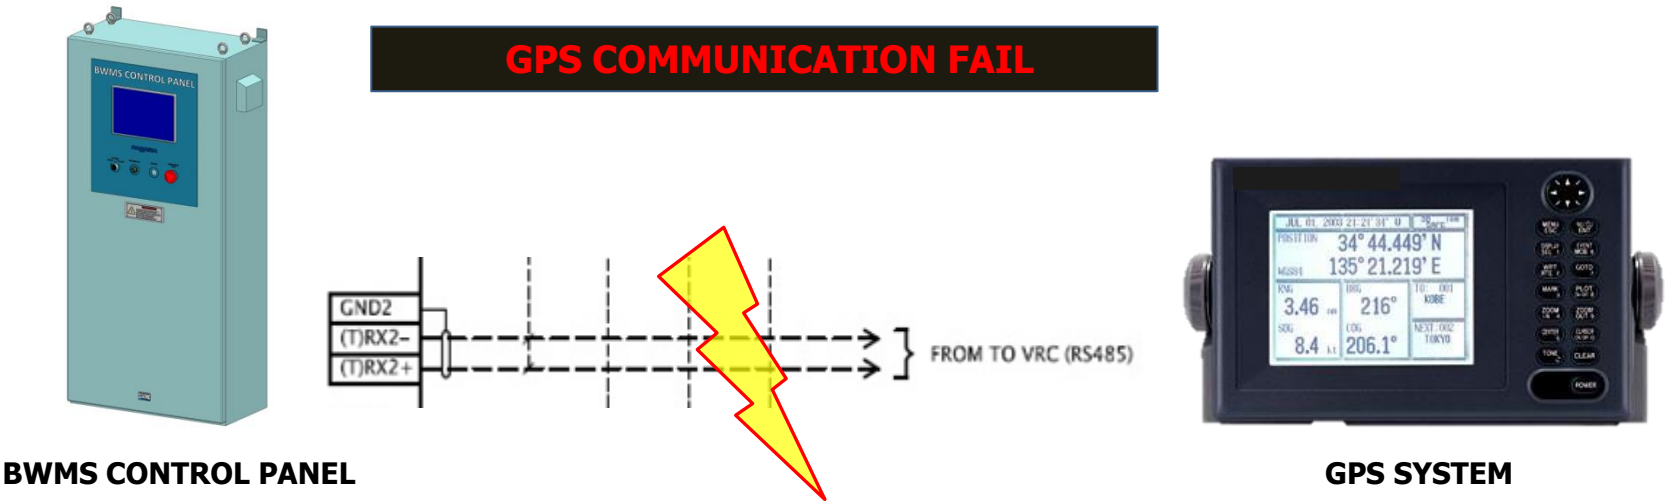
Alarm indicates that there is a loss of communication between PLC and GPS module.

Cause	Description	Action	Cause	Description	Action
1	Wrong GPS output signal	2	2	PLC module failure	1

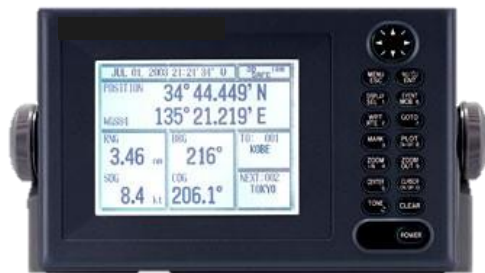
GPS SYSTEM

Cause ① : Wrong GPS output signal

Check ship's GPS is working correctly

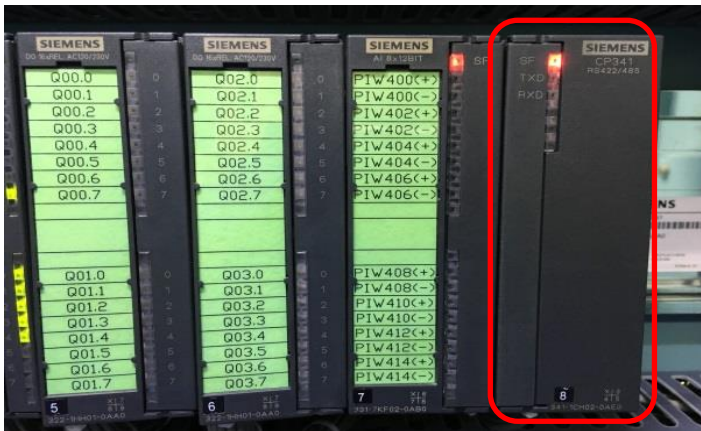
Cause ② : PLC module failure

Check the color of the green LED lamp of the PLC card

- Green LED Lamp flickering : Normal condition
- Green LED Lamp Off : Cable connection to be checked
- Red LED Lamp On : PLC card problem
